**H&S Bosma Dairy Lagoon Nos. 1, 2, and 3**

Administrative Order on Consent Docket No. SDWA-10-2013-0080

# H&S Bosma Dairy Lagoon Nos. 1, 2, and 3 Abandonment Plan

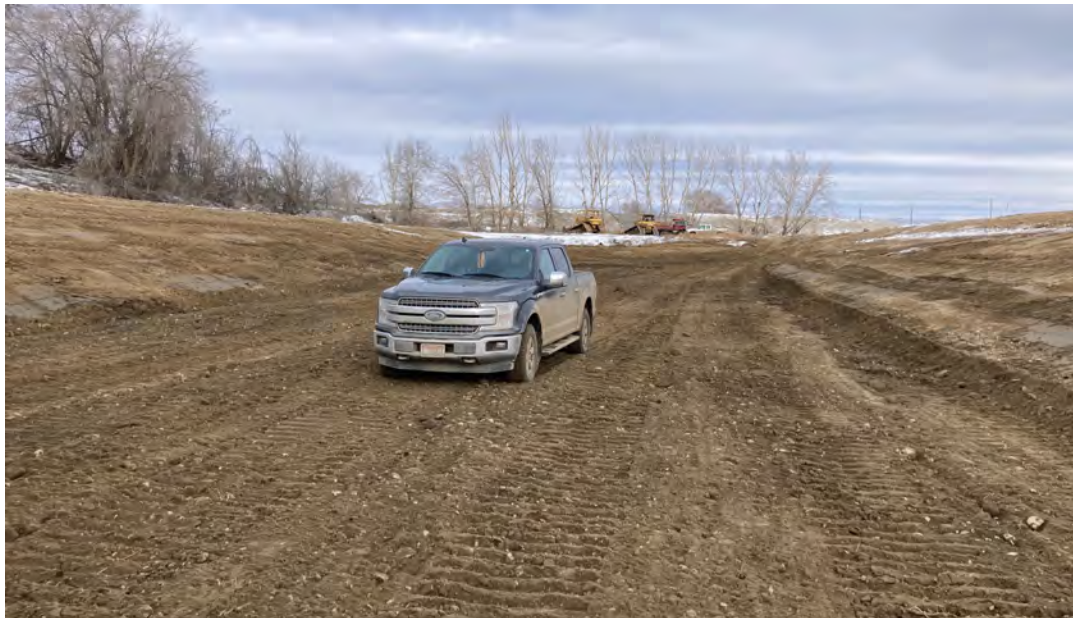
**Photograph 1**

- Lagoon No. 3 was removed from use in early fall 2021 and was emptied of manure and liquids. Soil sampling data were collected from the base and sidewalls of the lagoon to depths of 10 feet bgs in November 2021 (Section 2.3 and Table 2). An abandonment plan was submitted to EPA for review in January 2022 (Anchor QEA 2022). EPA subsequently determined that additional data were required prior to proceeding with finalization of decisions regarding the future lining or abandonment of this lagoon. In the meantime the Dairy has implemented a daily visual monitoring program to ensure that the lagoon remains dry (Photographs 1, 2, and 3). It has also installed two soil moisture sensors in the bottom of the lagoon (Photograph 3) to provide real-time monitoring of soil moisture levels at depths of

**Condition of Lagoon No. 3 in December 2021 Following Manure and Liquids Removal**

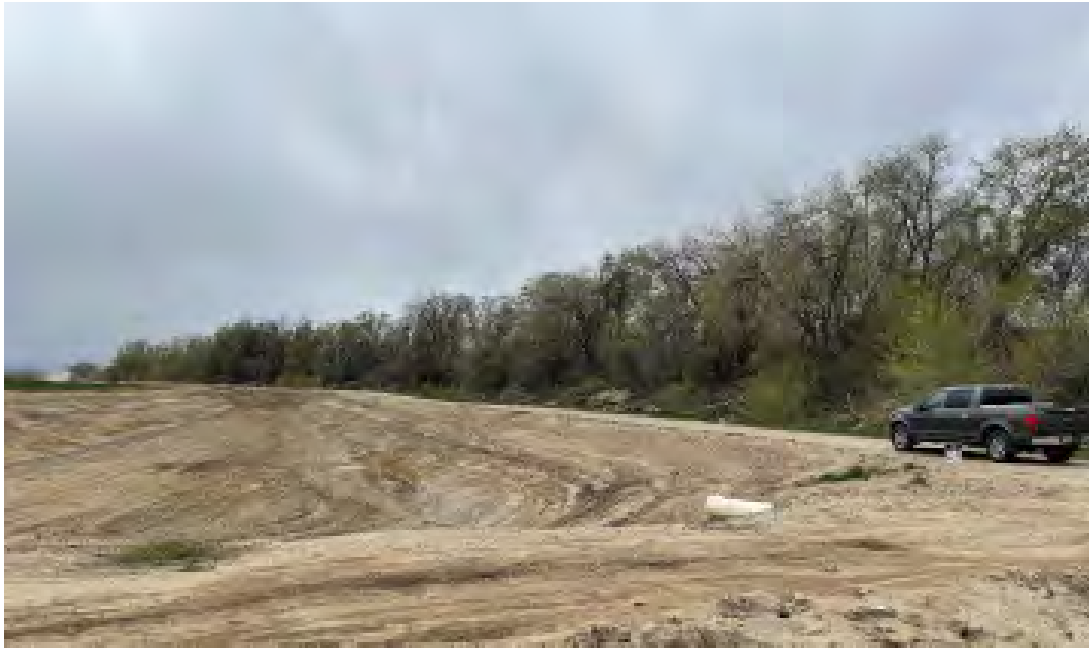
**Photograph 2**  
**Condition of Lagoon No. 3 as of April 4, 2022**

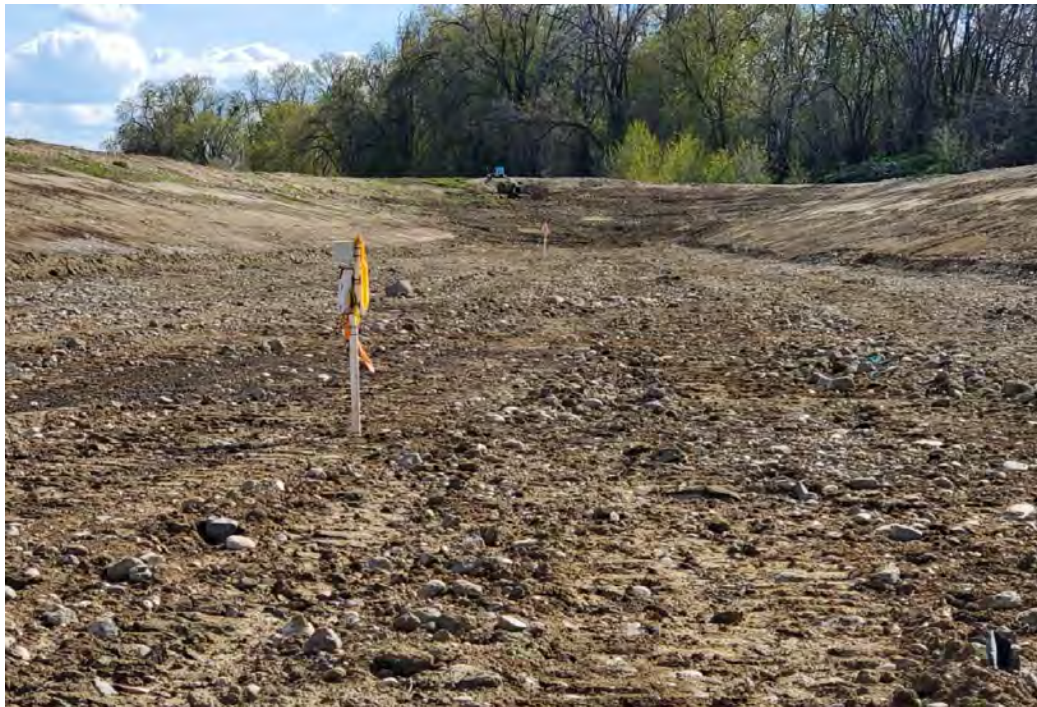
1 foot, 3 feet, and 5 feet bgs. These soil moisture sensors are actively maintained by Agrimanagement, Inc.

**Photograph 3**  
**Condition of Lagoon No. 3 Soil Moisture Sensors as Installed**

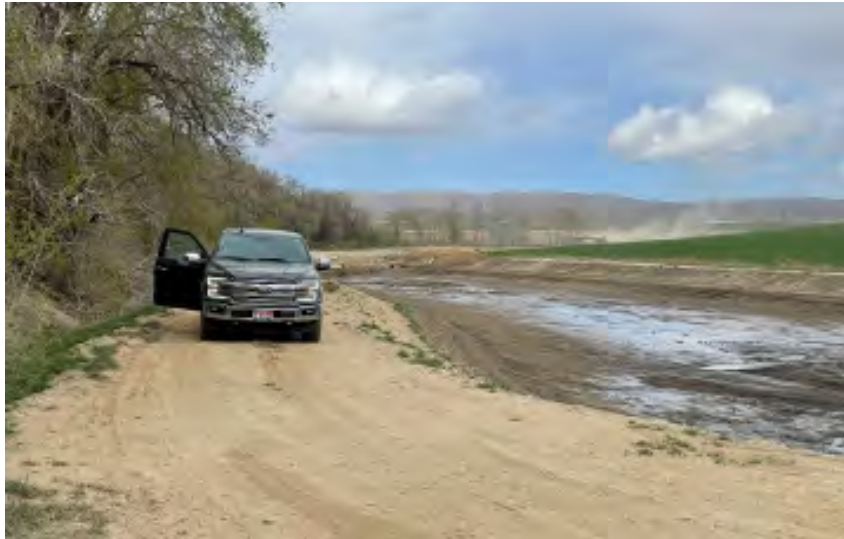
- Lagoon No. 2 has been taken out of service, and liquid manure has been removed. Lagoon conditions as of April 4, 2022, are shown in Photograph 4. Residual solid manure will be removed prior to June 1, 2021. Soil sampling is currently scheduled for the first 2 weeks of June. Lagoon No. 2 has been added to the Dairy's daily visual monitoring program along with Lagoon No. 3.
- Lagoon No. 3 has been taken out of service but still contains liquid and solid manure (Photograph 5). The liquid manure will be removed during May and June 2022. Residual solid manure will be removed in June and early July 2022. At that time the lagoon will be added to the Dairy's daily visual monitoring program along with Lagoon No. 3. Soil sampling is proposed for completion in July prior to August 1.

**Photograph 4**  
**Lagoon No. 2 as of April 4, 2022, After Liquids Removal**

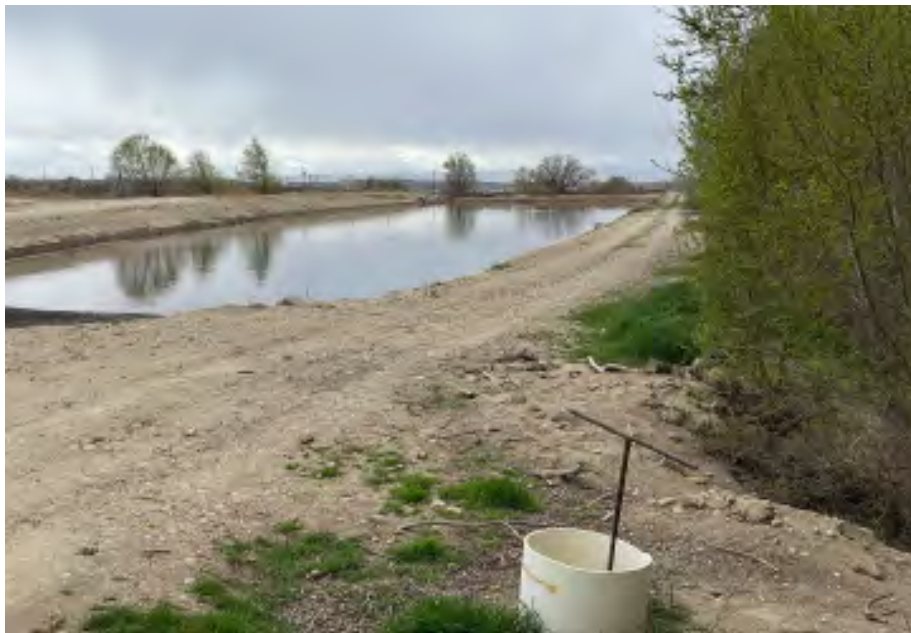
**Photograph 5**  
**Lagoon No. 1 as of April 4, 2022**

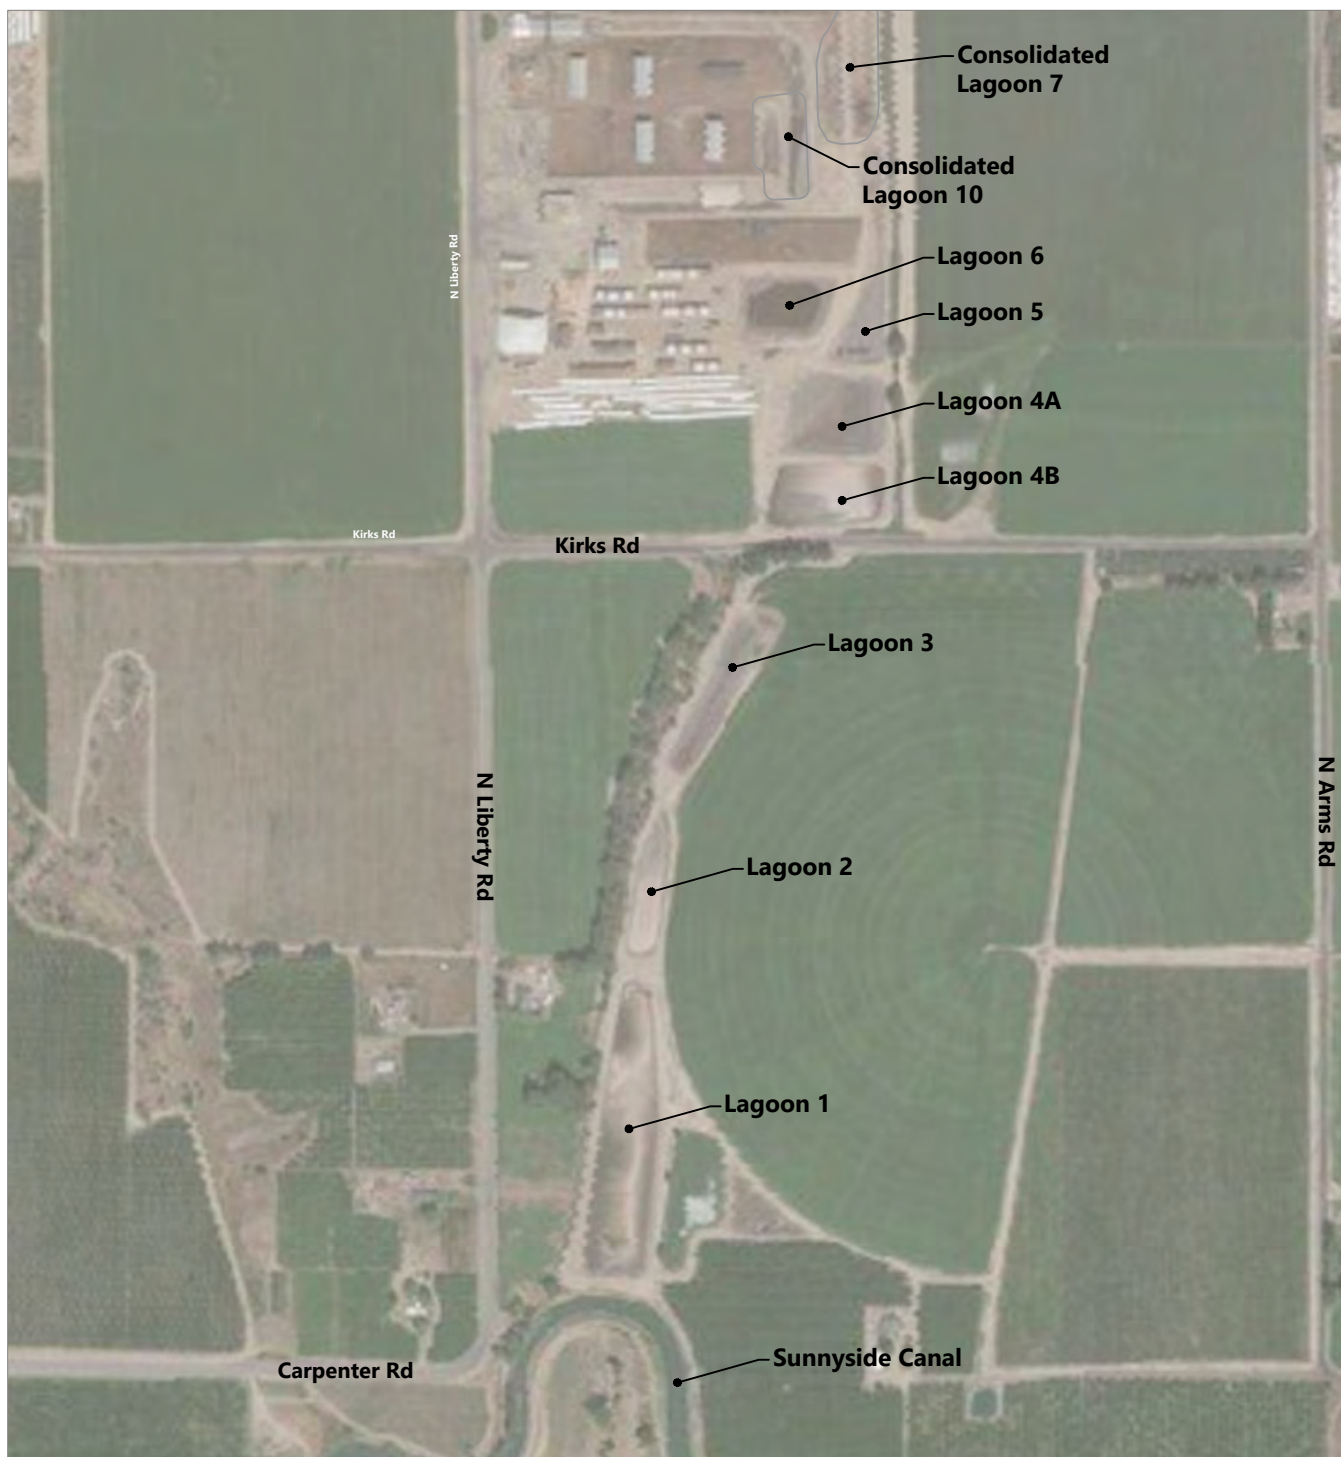
The Dairy is located at 5860 East Zillah Drive Road in Granger, Washington. Figure 1 shows the location of Lagoon Nos. 1, 2, and 3. Estimated dimensions and capacities of the existing lagoons are provided in Table 1.

**Figure 1**  
**H&S Bosma Dairy Lagoon Map**  
 Lagoon No.'s 1, 2 and 3 Abandonment Plan  
 H&S Bosma Dairy

The Dairy has implemented a program of lagoon consolidation and abandonments to reduce the number and footprint of its lagoon system. As part of this ongoing work, the Dairy is proposing to abandon Lagoon Nos. 1, 2, and 3 (Figures 1 and 2) located in the southern portion of the Dairy.

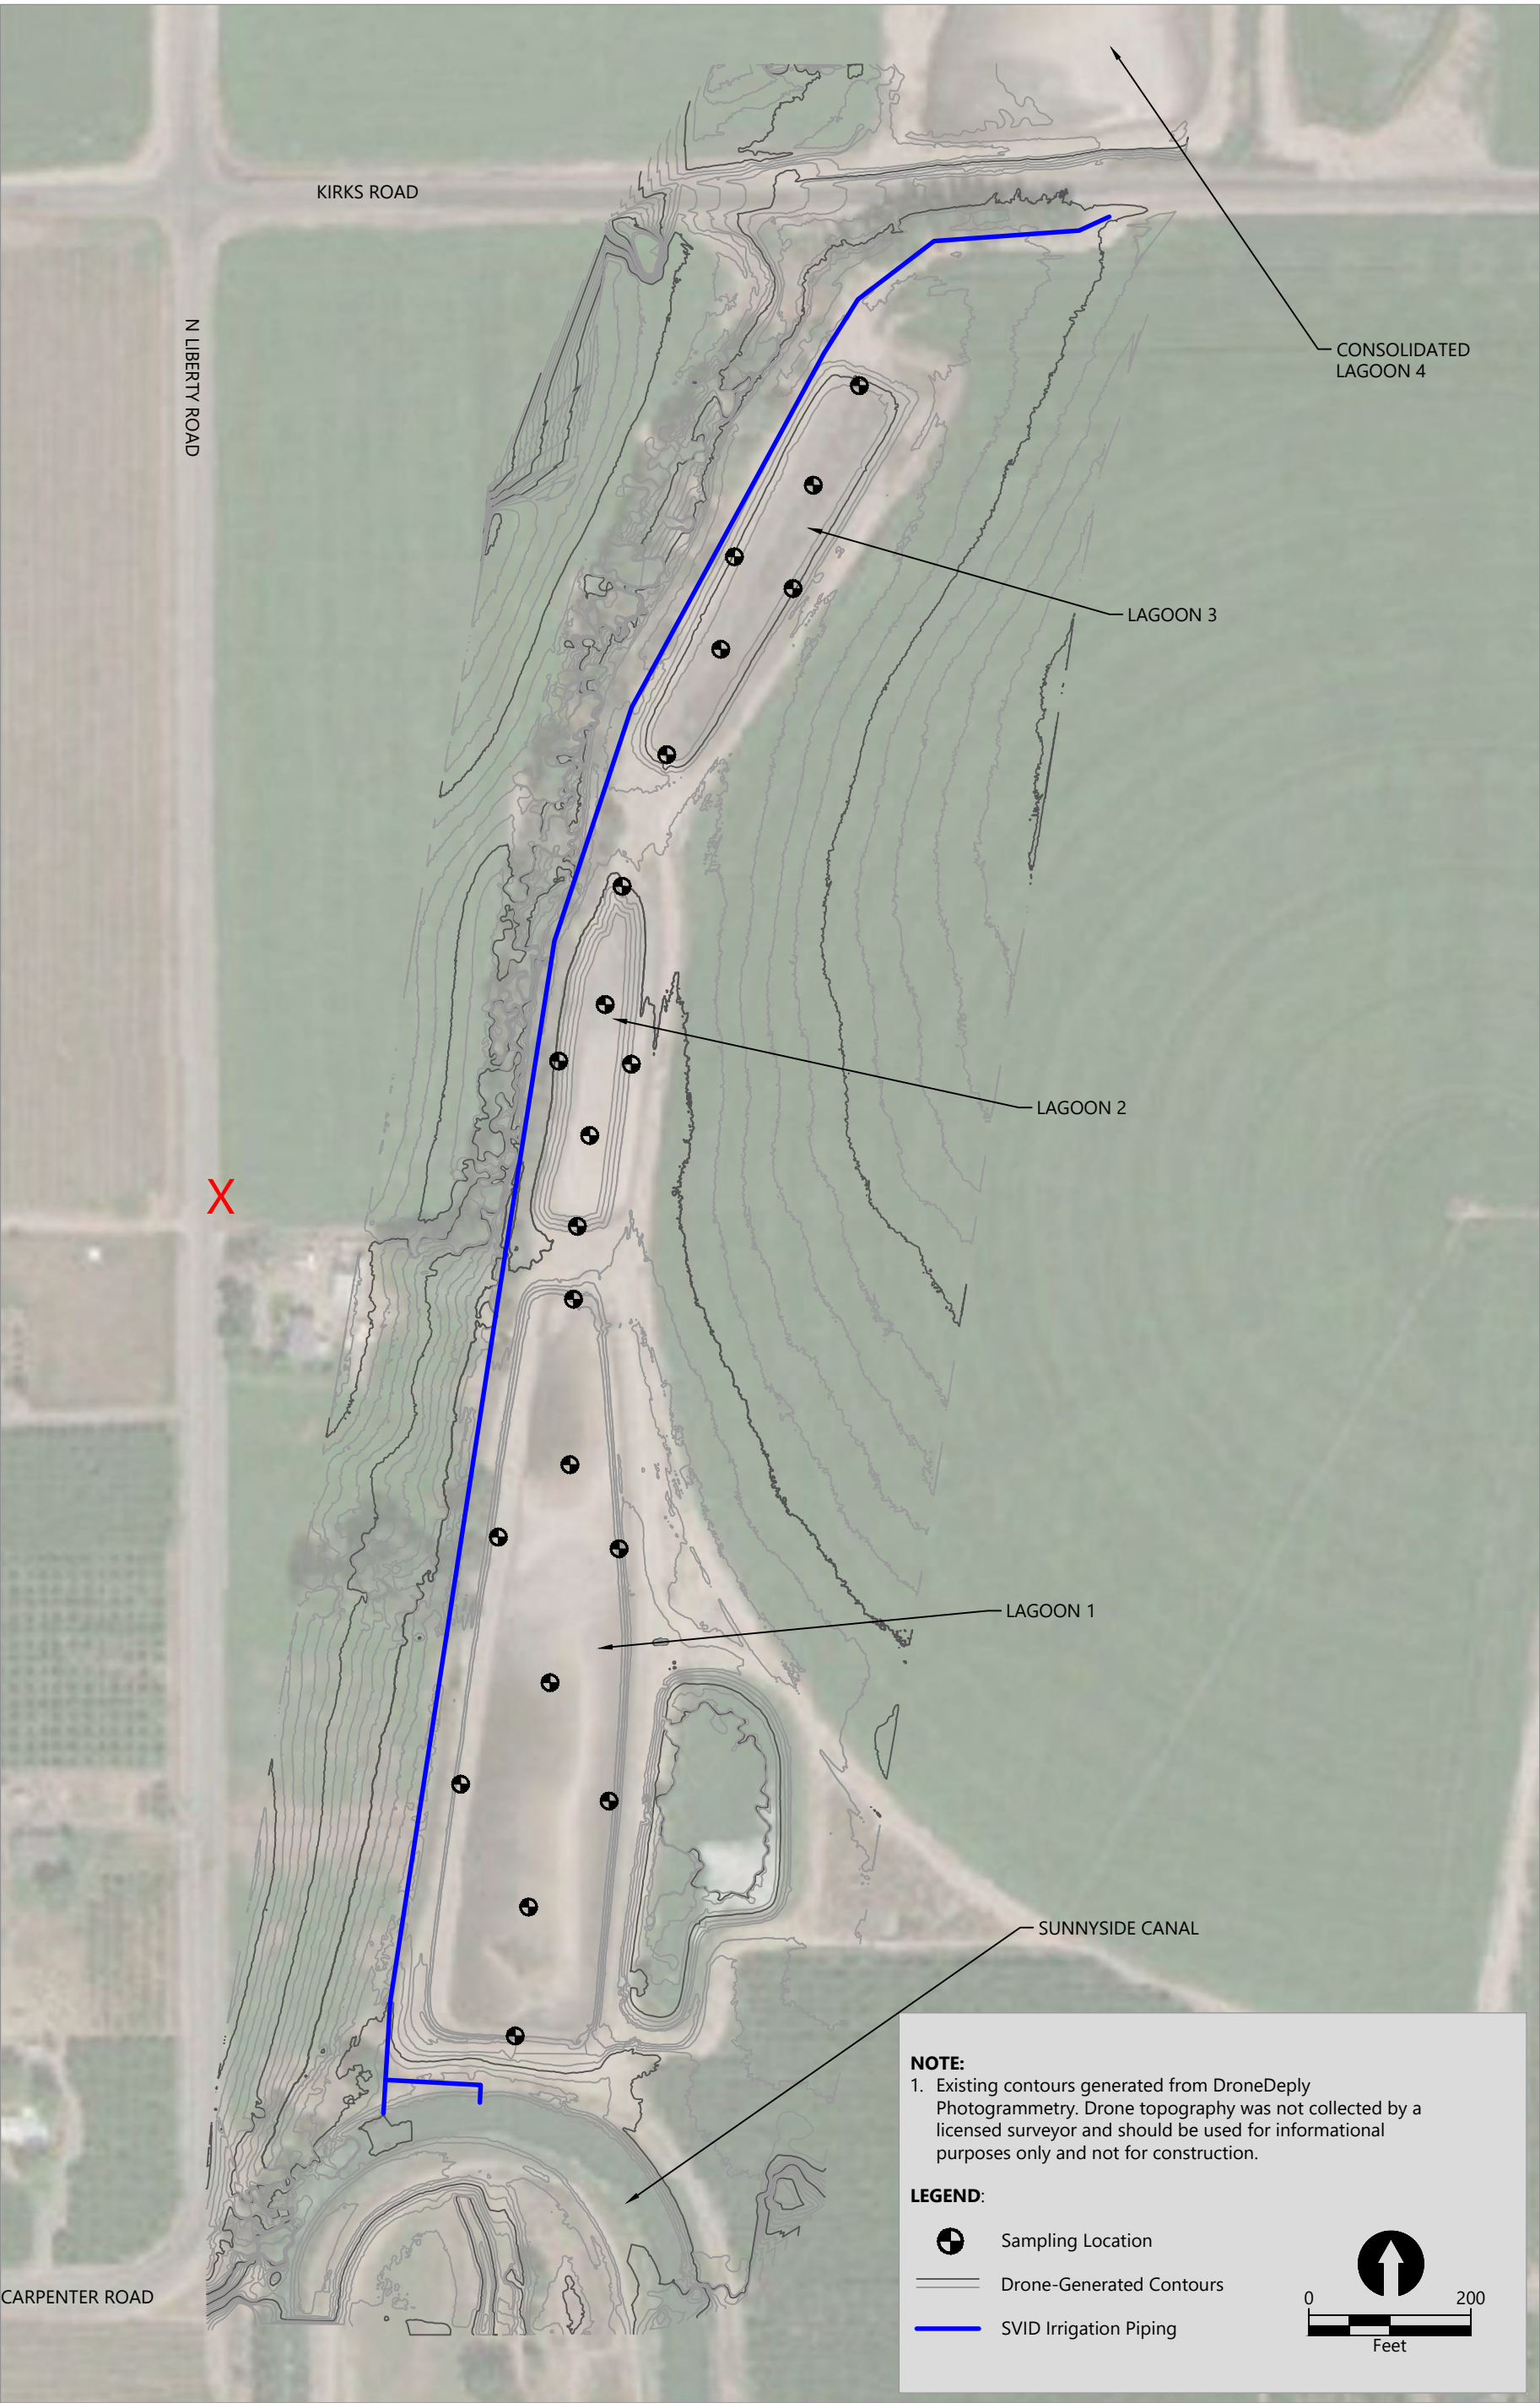
Publish Date: 2022/04/25 11:02 AM | User: jsenton  
Filepath: K:\Lagoons - 2022\Reports\Bosma\_1-2-3\_Abandonment\0996-RP03-2021-SamplingPlan-1\_2\_3\_Abandonment.dwg Figure 2

Following removal of the manure, soil testing was conducted within Lagoon No. 3 to document the ammonia and nitrate concentrations in the subsurface soil. Confirmation testing was conducted at six locations within Lagoon No. 3, including one sample from the lower portion of each sidewall and two samples from the lagoon bottom. Figure 2 shows the actual sampling locations.

Soil nutrient testing will include the six locations in Lagoon Nos. 2 and nine locations within Lagoon No. 1. As shown in Figure 2, the sampling locations include samples from the lower portion of each sidewall and multiple samples from the lagoon bottoms. Sampling will also be performed at the two sampling locations (SO-2 and SO-3 on the east and west sidewalls) that exhibited available nitrogen levels in excess of 45 mg N/kg at 10 feet bgs during previous soil testing (Table 2).

Prior to the 1990s, the SVID operated an irrigation return water canal in the natural depression that conveyed irrigation return water from flood irrigation systems in the area back to the main SVID canal. That open ditch was piped (24-inch-diameter PVC pipe) and buried by SVID in the early 1990s. The approximate location of the current SVID irrigation return line is shown on Figure 2.

Following removal of liquids, organic solids, and vegetation, soil testing will be conducted at the Lagoon Nos. 1 and 2 sampling locations shown in Figure 2. Consistent with the 2016 *Modified Lagoon Work Plan* (Anchor QEA 2016), the clean soil horizon is defined as soils with the sum of ammonia-nitrogen and nitrate-nitrogen equal to or less than 45 milligrams per kilogram (mg/kg).
